### A biological assessment of water quality in El Placer, Ecuador: The effect of agriculture on stream health and the quality of historical versus current drinking water sources

# A biological assessment of water quality in El Placer, Ecuador:

The effect of agriculture on stream health and  
the quality of historical versus current drinking water sources

El Placer, Tungurahua Province, Ecuador, South America

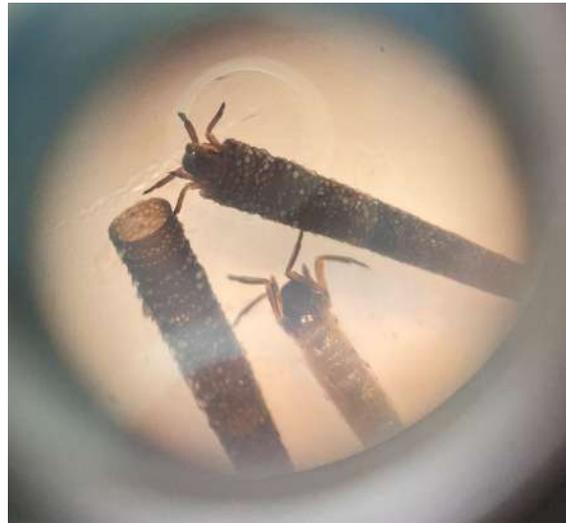
**Photo 1.** Macroinvertebrates from the pollution-sensitive order Trichoptera, family Leptoceridae.

Some orders of macroinvertebrates are more sensitive to contamination than others (Photo 1). The relative abundance of highly-sensitive orders provides insight into water quality. Several indices exist that assign scores to different macroinvertebrate families based on their tolerance to pollution; the sum of family scores at a given study site can indicate its water quality. Furthermore, bioassessments of macroinvertebrate populations are favored because these organisms are almost universally found in freshwater ecosystems, collection methodology is well-defined, and there are countless resources for identification (Stark et al., 2001).

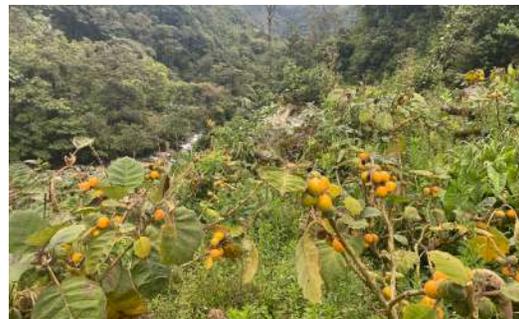
**Photo 2.** Naranjilla groves near Site 1 of Tía Anita Stream.

Site 1 is located at an altitude of 1544 meters, the lowest altitude of the three sites. Although its direct surroundings are secondary forest, it is about 100 meters from a naranjilla grove (Photo 2). Fungicides, insecticides, and herbicides are applied every three weeks to the hybrid species of naranjilla. Every two years, the location of the grove shifts slightly, so it is possible that in the past the grove was closer to the stream.

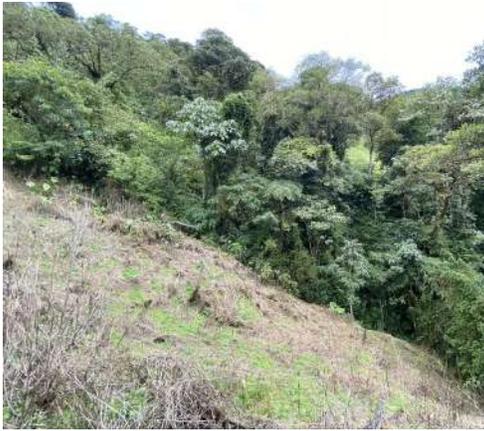
**Photo 3.** Tree tomato groves near Site 2 of Tía Anita Stream.

Site 2 is located at an altitude of 1745 meters. One side of this site is covered in tree tomato groves, while the other side is secondary forest (Photo 3). Fungicides and insecticides are applied monthly to the tree tomato grove, whereas herbicides are applied every two months.

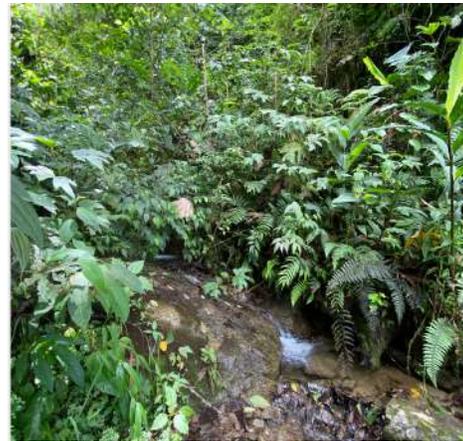
**Photo 4.** Site 3, secondary forest site of Tía Anita Stream.

Site 3 is located at an altitude of 1754 meters, the highest altitude of the three sites. This site is surrounded completely with secondary forest (Photo 4). There are no signs of alteration in the surrounding environment, except for a small path leading to the stream.

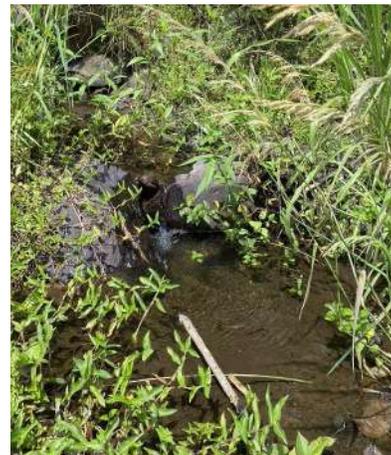
**Photo 5.** Site 4, El Placer's historical water source.

Site 4 is El Placer's historical drinking water source (Photo 5). It is located at an altitude of 1540 meters. This site is directly off the main road, Vía a Baños, and adjacent to a mandarin grove. Water flow in this stream was depleted almost completely after the San Francisco Hydroelectric Project.

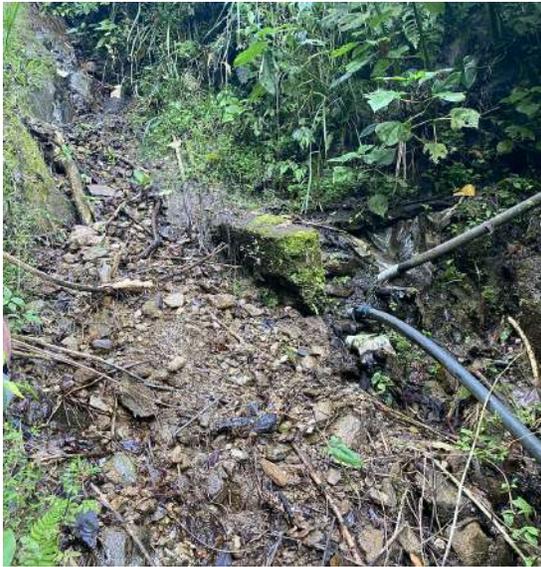
**Photo 6.** Site 5, El Placer's current water source.

Site 5, part of El Placer's current drinking water source, is located at an altitude of 1692 meters. This site is a stream from one of the three natural water sources that are combined in order to supply El Placer with water. The pipes that bring this water to the village are visible in Photo 6. Located on the steep slopes of Nueva Libertad Mountain, Site 5 is surrounded completely with secondary forest.

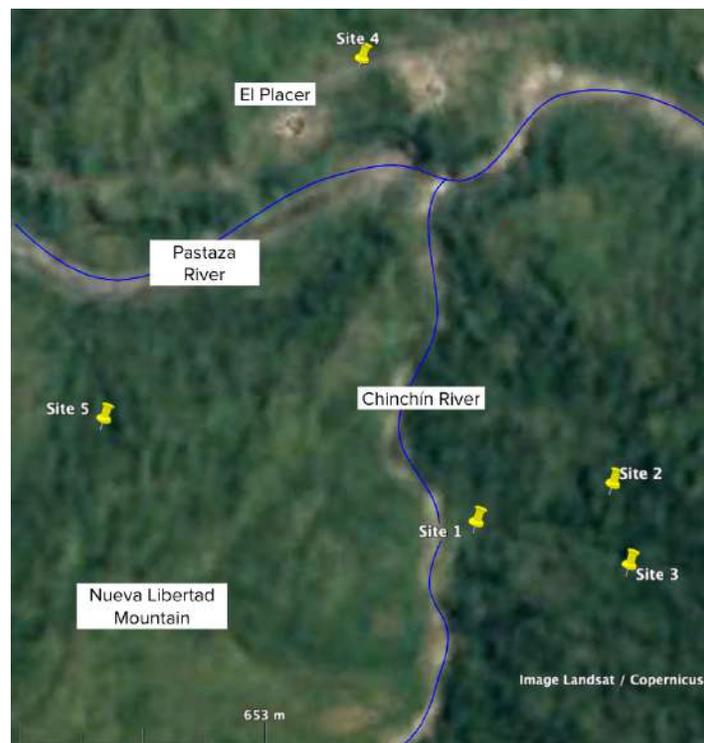
**Figure 1.** Map of study sites, mapped using Google Earth Pro.

A map of all study sites can be seen below (Figure 1):
